**RE: License No. SUA-1534  
Docket No. 40-8943  
2002 Annual Pond Inspection Report**

**CROW BUTTE RESOURCES, INC.**

**CROW BUTTE MINE  
DAWES COUNTY, NEBRASKA**

**2002 POND INSPECTION REPORT**

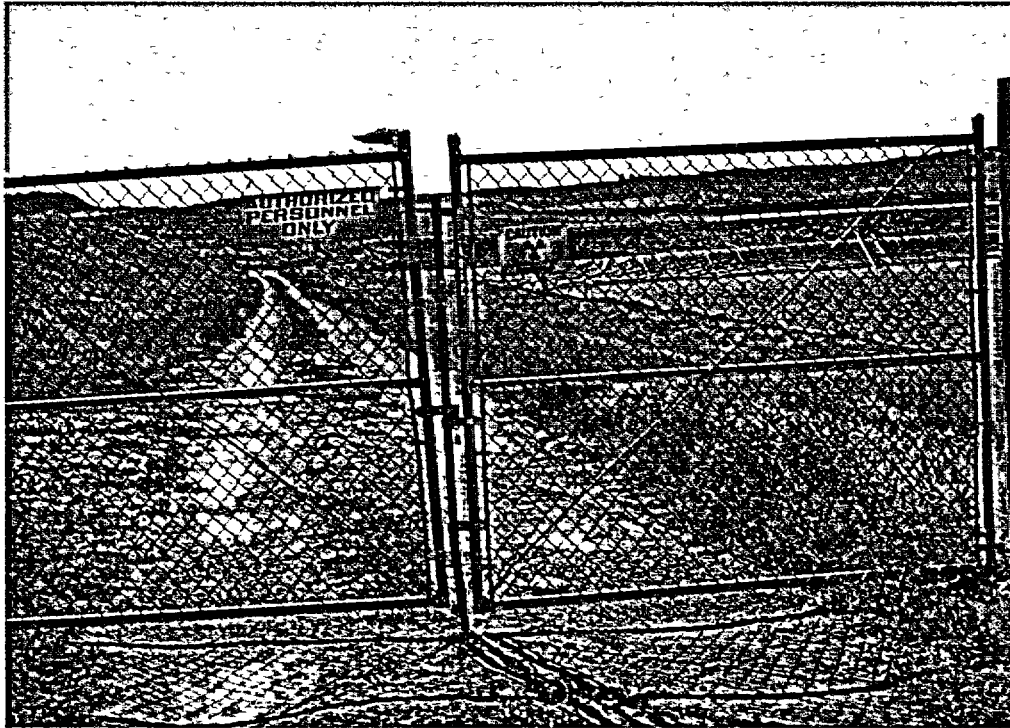
**Photo shows the entrance gate to the commercial evaporation pond area.**

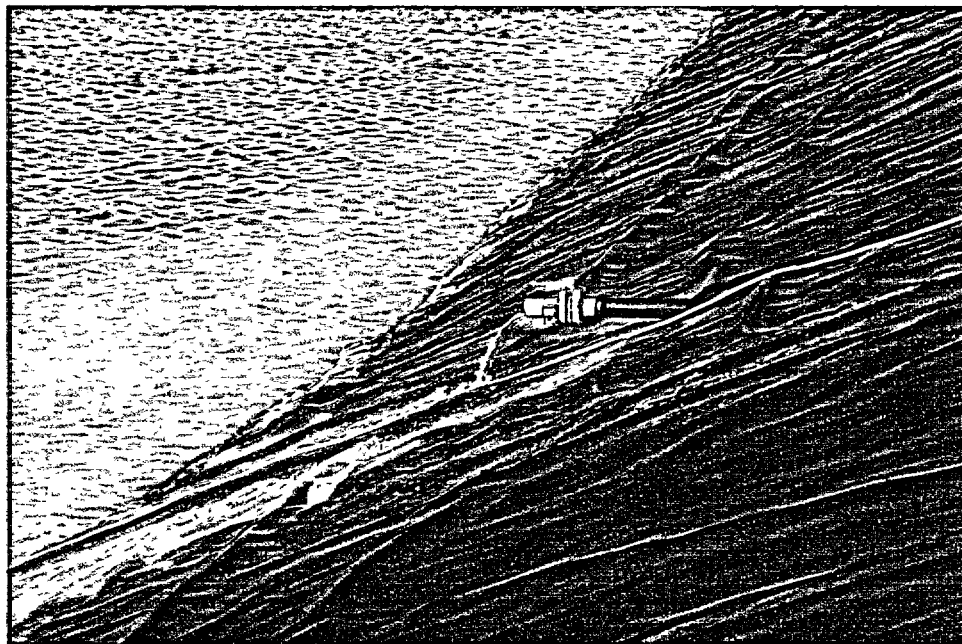
As I walked to the south along the berm of pond 1, I noticed several boroughs which I would assume were muskrats or gophers. I did not notice any damage of the HDPE liner resulting from rodents chewing on the liner. Pond 1 was receiving influent waters. I did not observe any tremmie tubes attached to the influent line. The water was free falling onto the HDPE liner. It was dropping about two feet.

**Photo shows the influent line for pond 1. Note there is no tremmie tube at outlet.**

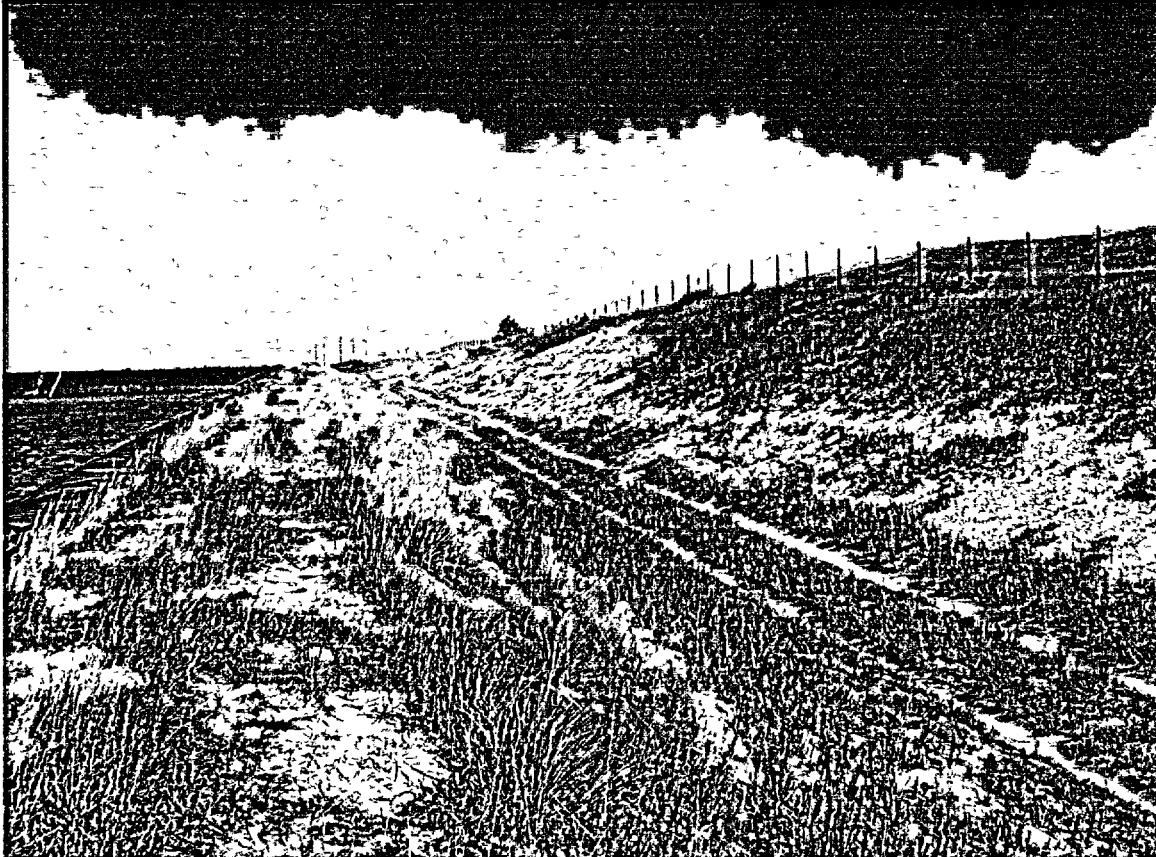
The east slope of the pond embankment had good vegetation on the back slope. The east slope of the diversion ditch had fair vegetation on the slope. I did notice some erosion rills along the back slope. The rills were less than 12 inches deep. I did not consider them major. It would be nice to attempt to vegetate the section with the erosion rills. The existing erosion is probably due to the lack of top soil on the surface of the back slope.

**View to the north with pond 1 on left & diversion ditch on middle right. There are small erosion rills on the east bank of the diversion ditch. This does not affect the function of the ditch. Note the limestone gravel stops on part of the berm top.**

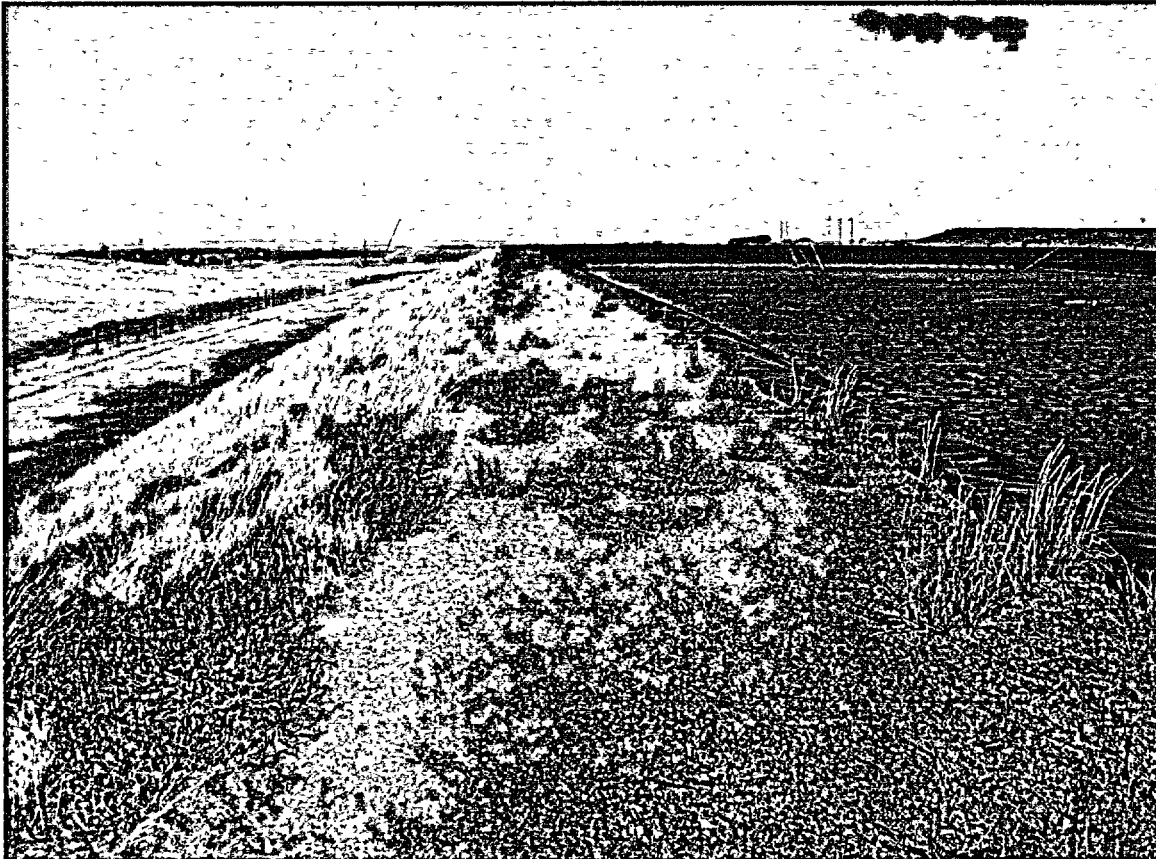
**Photo shows the west berm of pond 4. Note the gravel surfacing and the good vegetation on the embankment slope. View if looking to the north. Pond 3 is on the north of pond 4.**
